X The objective of Project 1.8b was to investigate the blast damage sustained by drag-sensitive targets when the blast wave passes over rough, hilly terrain to the target location. Of particular interest was the difference in the damage sustained by those targets which were positioned to take maximum advantage of terrain irregularities and the damage sustained by those targets placed over level terrain at corresponding distances.

This report presents the final results of one of the 46 projects comprising the military-effect program of Operation Plumbbob, which included 24 test detonations at the Nevada Test Site in 1957.

EFFECTS of ROUGH TERRAIN on DRAG-SENSITIVE TARGETS

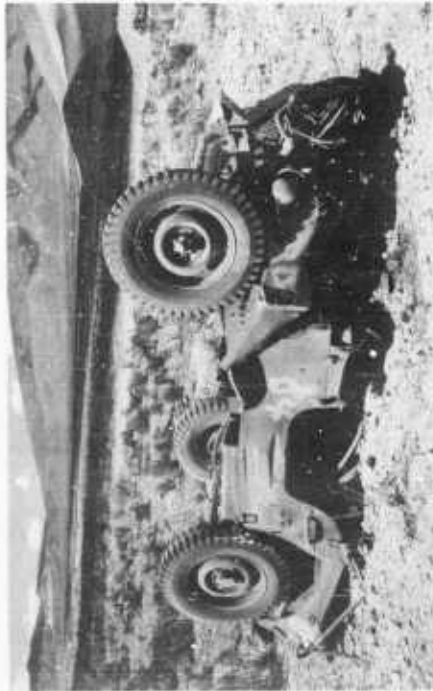
Station 6.02 (SO) 2,760 feet.

6.01	2,381 SO		10.2	630	Severe; vehicle demolished.	—	—	—
6.01	2,381 FO		10.2	430	Severe; vehicle upright, intact; body and frame ruined.	—	—	—
6.02	2,760 SO		8.8	150	Severe; vehicle upside down, body, frame, radiator, steering ruined	—	—	—

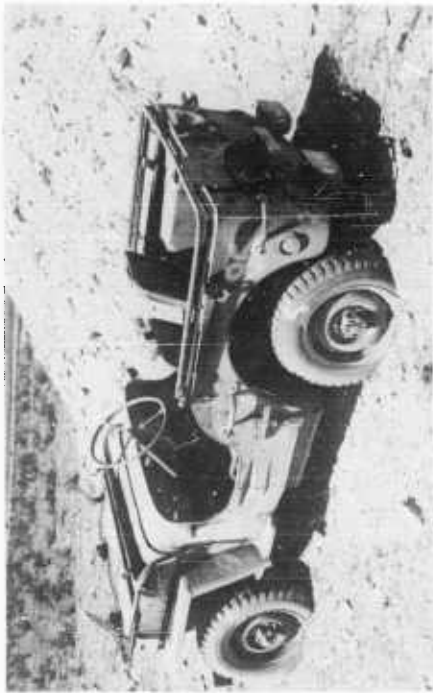
Station 6.02 (SO) 2,760 feet (behind artificial revetment).

6.02	2,760 FO		8.8	150	Severe; vehicle upright, body badly damaged, frame bent, steering mechanism bent.	—	—	—
6.02*	2,760 SO		8.8	0	Light; vehicle upright, no damage	0	0	O

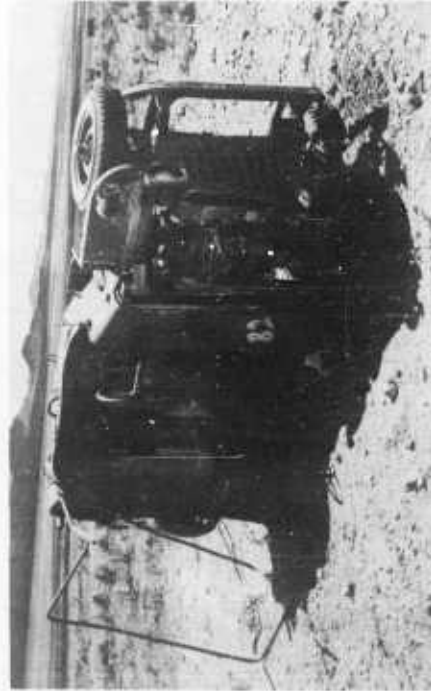
Station 6.04 (SO) 3,406 feet.

6.04	3,406 SO		6.4	110	Moderate; vehicle on right side, body severely damaged, right front wheel torn off, steering mechanism bent.	5.3	13.3	O
6.04	3,406 FO		6.4	25	Moderate; vehicle upright, radiator and body damaged.	2.0	6	O

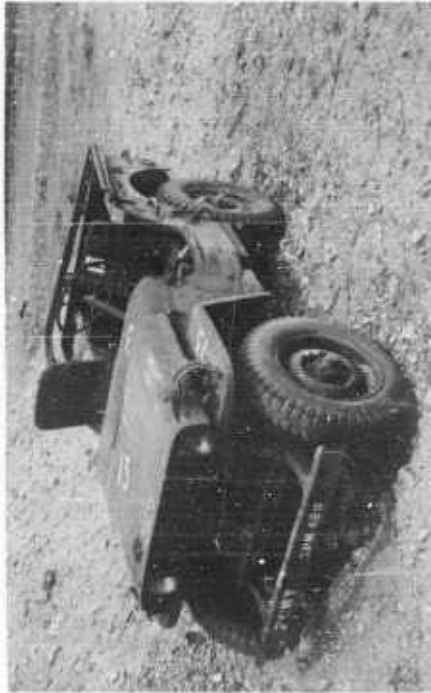
Station 6.04 (SO) 3,406 feet (behind artificial revetment).

6.04*	3,406 SO		6.4	0	Light; vehicle upright, no damage.	0	0	O
6.05	3,875 SO		7.2	20	Moderate; vehicle upside down, body badly bent, steering mechanism ruined.	3.5	9.5	O

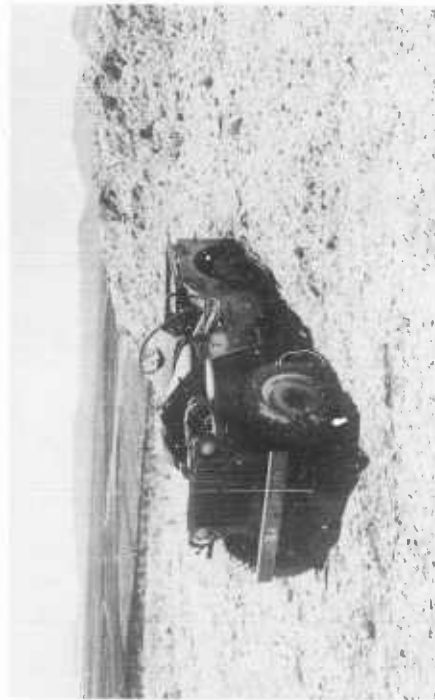
Station 6.07 (SO) 2,548 feet (behind artificial revetment).

6.07*	2,548 SO	Hill	12.5	0	Light; vehicle upright, hood missing, cowlings bent, windshield broken.	0	3	O

less of their distance from ground zero (2,548, 2,760, 3,218, or 3,406 feet) or whether they were on level ground or hills. The vehicle behind these earth mounds received no damage, while those exposed unprotected at the same location received moderate-to-severe damage.

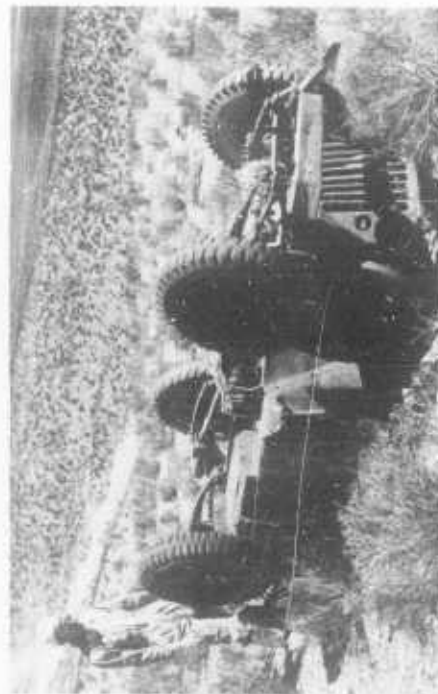
Station 6.09 (SO) 3,218 feet (hill).

As shown in Figure 13, the damage experienced by the vehicles directly on Line 2 was identical at corresponding distances on the control line, with one exception. The side-on vehicle at Station 6.09 (a hill station) was severely damaged, while the vehicles in front of this station, as well as those equal distances on the control line, were only moderately damaged. Although severe damage is implied at this ground range, it is unusual to have those vehicles (surrounding and preceding the severely damaged vehicle) sustain only moderate damage.

Other significant examples of the protection afforded by sharp terrain features occurred at Stations 7.03 and 7.08. At Station 7.03 the vehicles survived the blast and were not damaged, while those vehicles at Station 6.09, which were at the same distance, were heavily damaged. This occurred because Station 6.09 was exposed on a hill and

6.08	2,914 FO	Dale	10.8	0	Moderate; vehicle upright, radiator ruined, hood bent, headlights broken.	1.5	4.8	0
6.09	3,218 SO	Hill	8.2	220	Severe; vehicle upside down, engine mounts sheared, body ruined, frame bent.	—	—	—

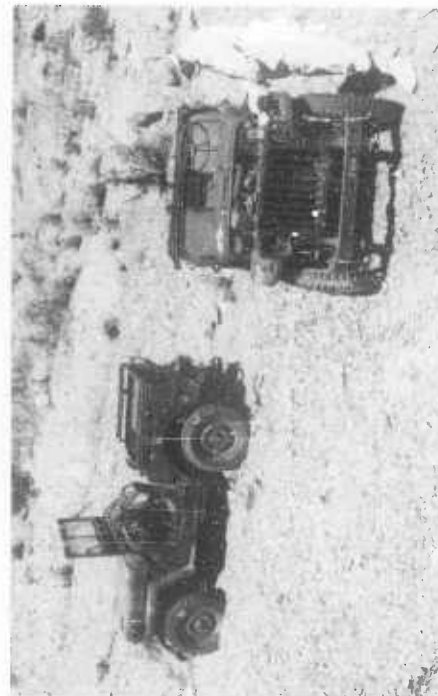
Station 7.03 (SO and FO) 3,218 feet (dale).

7.03	3,218 SO	Dale	9.0	0	Light; vehicle upright, scorched, seats missing.	0	0.5	0
7.03	3,218 FO	Dale	9.0	0	Light; vehicle upright, scorched, hood missing.	0	0.5	0

7.03 was shielded by a bluff. An even greater contrast in damage was observed between Stations 6.13 and 7.08. Station 6.13 (1,836 feet) was completely demolished, while 7.08 (1,728 feet and well within the 90-percent-severe-probability radius) was only moderately damaged. The apparent reason for this was that Station 7.08 was located in a narrow gully which provided shielding as well as restriction of movement (Figure 15).

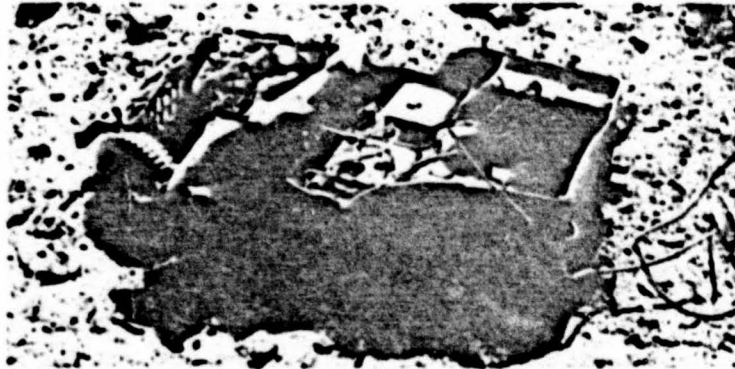
Station 7.08 (FO) 1,728 feet.

7.08	1,728 SO	Gully	54.0	0	Moderate; vehicle upright, front end of body badly damaged, radiator ruined, steering mechanism ruined.	8.5	14.5	F
7.08	1,728 FO	Gully	54.0	0	Moderate; vehicle upright, front portion of body crushed, radiator and steering ruined.	9.0	18	F

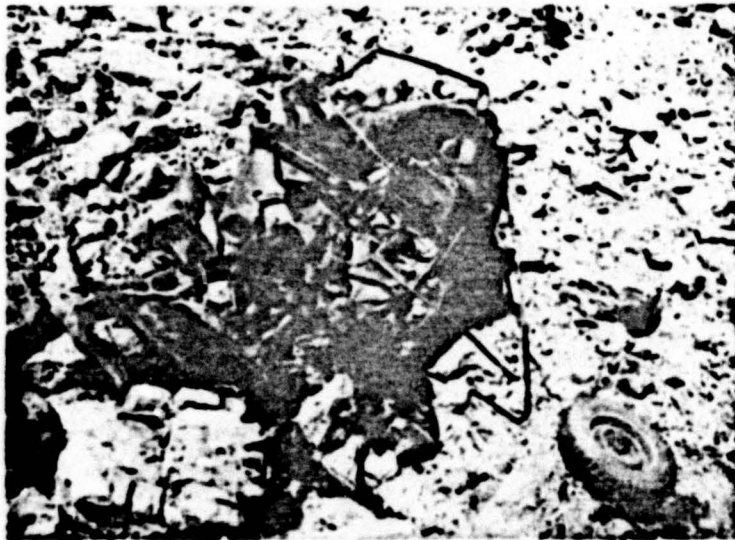
Station 6.13 (FO) 1,836 feet.

6.13	1,836 SO	Ravine	24.5	100 to 1,500	Severe; completely dismembered.	—	—	—
6.13	1,836 FO	Ravine	24.5	100	Severe; completely demolished.	—	—	—
7.06	2,341 SO	Back of Hill	15.7	100 to 600	Severe; vehicle upside down, engine and grill attached to frame, body stripped.	—	—	—

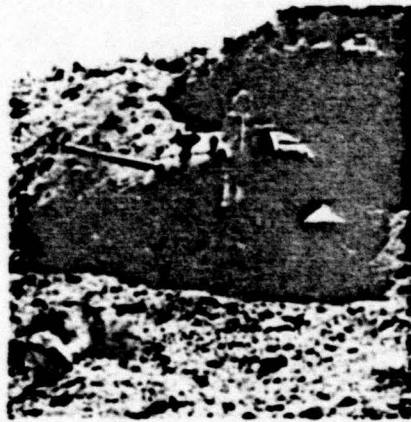
Station 7.02 (b).

7.02(a)	2,840 FO	Dale	12.6	0	Light; vehicle upright, speedometer broken.	0	1	0
7.02(b)	2,840 SO	Dale	12.6	0	Light; vehicle upright, battery broken, hood blown off.	0.3	4	0

6.11	4,115 SO	Hill	7.0	120	Moderate; vehicle upright, front springs and U-bolt broken, body badly damaged.	3.5	10.5	0
6.11	4,115 FO	Hill	7.0	18	Moderate; vehicle upright, radiator and hood damaged.	1.5	3.3	0
M48	2,840 SO	Dale	12.6	0	None; vehicle upright, no damage.	0	0	0

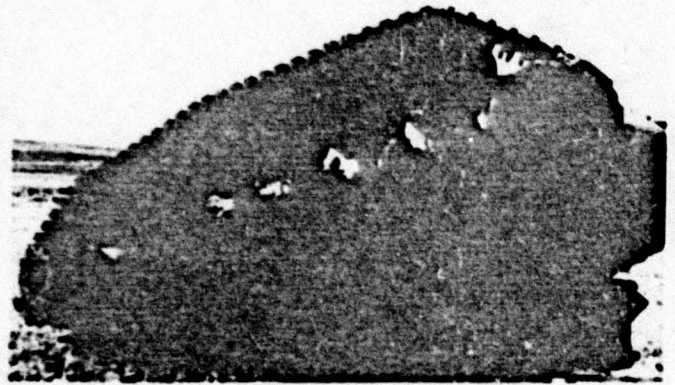
Station 9008.

7.07	2,975 FO	Gully	11.6	5	Moderate; vehicle upright, radiator destroyed, steering wheel and column bent.	4.0	7.8	O
9008 (M48)	1,231 SO	—	65	15	Severe; vehicle upside down, burned, engine melted.	—	—	—
